PROJECT PROFILE: San Antonio, Texas University of Texas

Completion Date:	July 07, 2023
Project Type:	WTI/Pure Air Control Services
Project Size:	Two Air Handler Units at 25,000 cubic feet per minute each
Services Used:	HVAC New Life Restoration

HVAC New Life Restoration

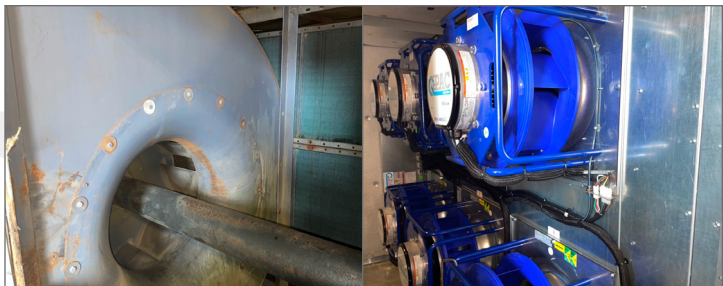
Broken blower wheel removed Fan Array bulkhead wall installed

Blower Removal and New Fan Array

The next step was to remove the old blower assemblies and motors. Then the new fan array that was re-engineered specifically for each AHU was installed. First, the pre-built bulkhead wall was secured into place. Then the fans are fitted into their channel locks and wired for service. Fan array retrofits provide improved efficiency and redundancy since there are no more bearings, belts, or shivs to maintain.

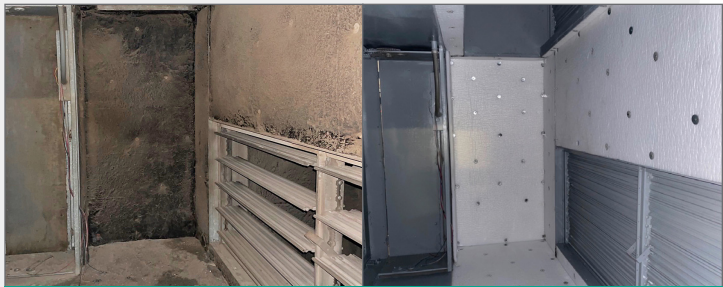
Before PURE-Steam with old insulation Floor Coating, PURE-Cell Insulation

PURE-Steam AHU and Coil Cleaning

The first step was to environmentally remove any old and contaminated fiberglass insulation. After that, the units were thoroughly HEPA-vacuumed of residual debris. Next, airflow resistance readings were taken across the cooling coils. This is known as a Coil Cleanliness Verification test, or CCV. Then the interior of the unit was masked off and sanitized with WTI Pure Air's proprietary PURE-Steam process. This included a deep cleaning of the cooling coils as well. PURE-Steam utilized bio-enzyme treatments and high temperature, low-pressure steam to penetrate through debris lodged in the coil. CCV readings were also taken after the cleaning. This process improves AHU performance and indoor air quality.

High Performance Coatings and Fiberglass Free Insulation

The final step in the HVAC New Life restoration process includes refinishing the metal components of the units with high performance coatings that are corrosion resistant, flexible, and very low VOC. This includes relining the drain pans with a multi-part polyurethane coating that is designed and tested for HVAC systems. The entire process is completed with the installation of new, fiberglass-free insulation that is moisture resistant to prevent future degradation.

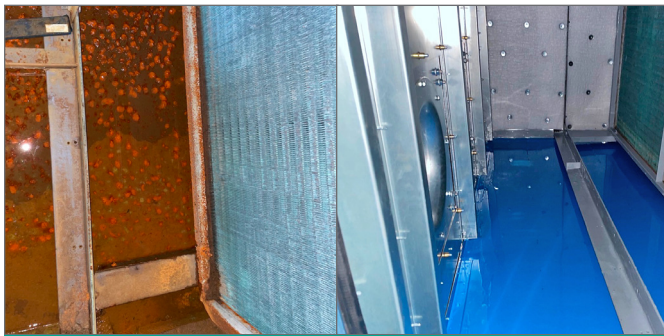
Before New Life

After New Life

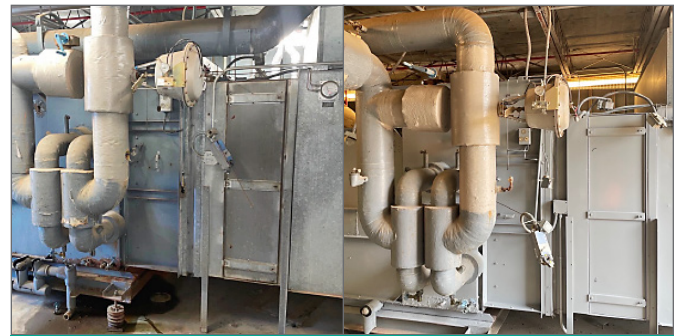
Before New Life

After New Life

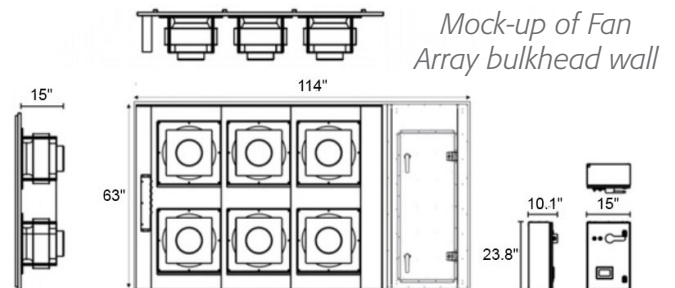
Mock-up of Fan Array bulkhead wall
